**Propery Inspection Report**

2673 Milton, Fullerton, CA. 92831
Inspection prepared for: Ketchum University
Date of Inspection: 3/5/2015 Time: 10:00 A.M
Age of Home: 36 Years Old Size: 1, 202 Square Feet per Assessor
Weather: Recent Rain

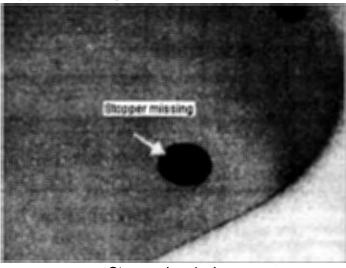
# 15. Bath Tubs

- · Stopper is missing.

Stopper is missing.

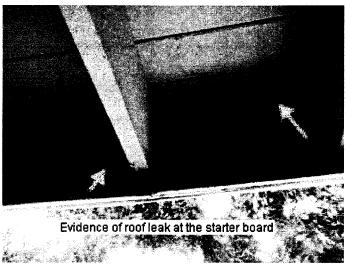
# 16. Patio and Porch Condition

• Evidence of water intrusion on the starter board on the balcony area.

Evidence of water intrusion on the starter board on the balcony area.
